HFA: New York State Homes and Community Renewal
Title: Adaptive Reuse: From Outmoded to Occupied; Re-energizing Communities by Preserving Their History
Category: Rental Housing
Subcategory: Preservation and Rehabilitation

AP Lofts, Buffalo, NY

AP Lofts at Larkinville is the adaptive re-use of the former Atlantic & Pacific Tea Company Warehouse built in 1910 into 147 units of workforce housing in the City of Buffalo, Erie County.

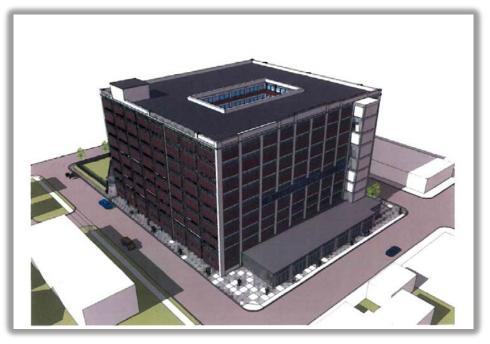
Architects Rendering-note how the center of the building will be carved out to create the necessary light well for apartments in the inner core

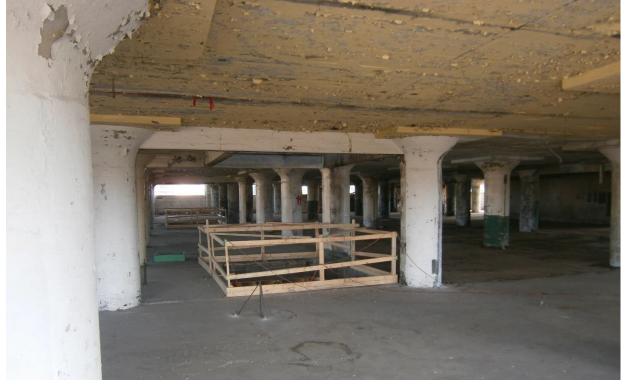
Gutted floors circa August 2017. The framed out area is where one of the elevators was removed.

In its day as a warehouse/distribution center, goods and groceries of all types were stored throughout each floor. The floors were usually divided into the type of good being stored there, such as a floor for produce, a floor for meats and a floor for dry goods and so on. Each floor was served by four huge elevators; two to bring goods up from rail cars, and two to bring goods down to the truck loading docks.

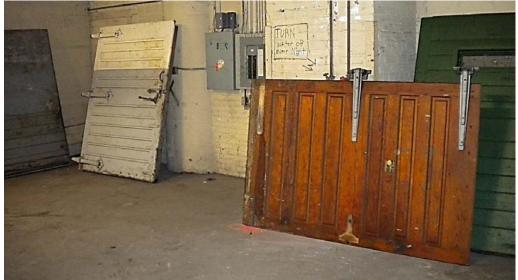
In keeping with historic requirements, original elements will be preserved and re-used when feasible. Above are two of the many solid wood refrigerator doors that will be preserved and hung as wall décor in the hallways.

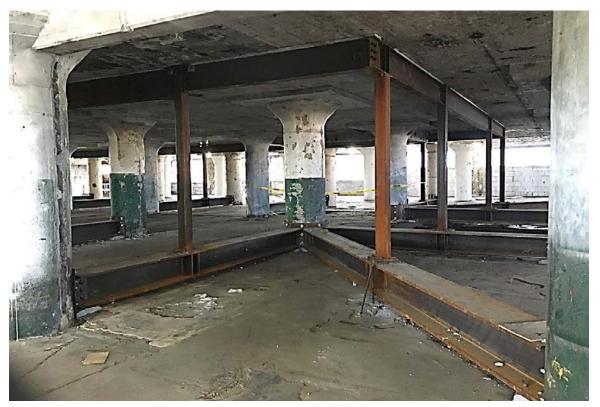
The process of cutting a central core into structural concrete slabs begins with the placement of steel girders at the base slab to create a "cage" of steel posts and beams which frame the perimeter of the new opening. Everything within that border will be removed.

A finished frame. The posts align with the posts below and above to evenly distribute the weight

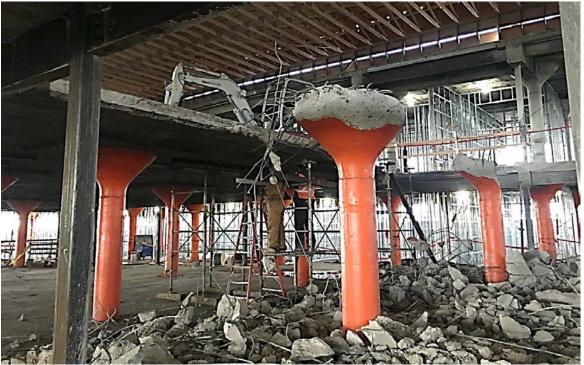
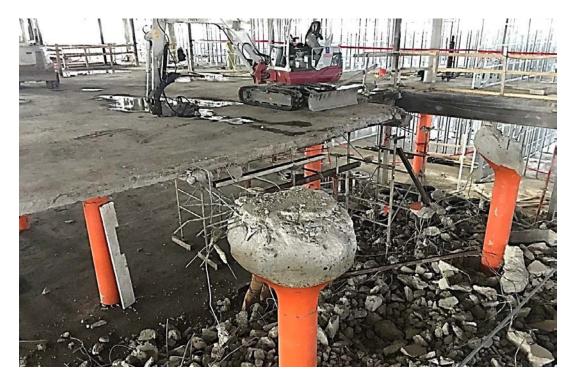
The slab is first cut to the perimeter dimension of the frame below it, and then the concrete slab is chopped away. The original concrete capital columns will be removed separately.

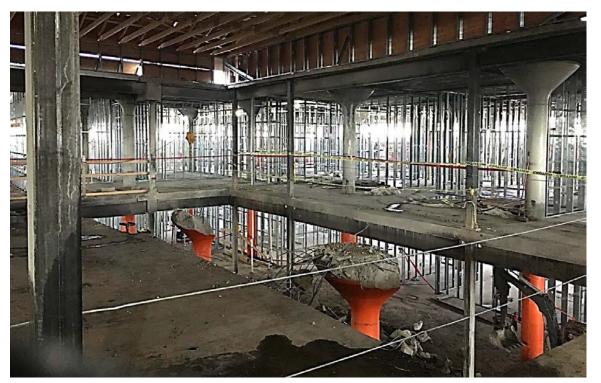
View of a partially finished cut at the top floor. Note the framing of the roof opening above and initial partition framing for the apartments beyond

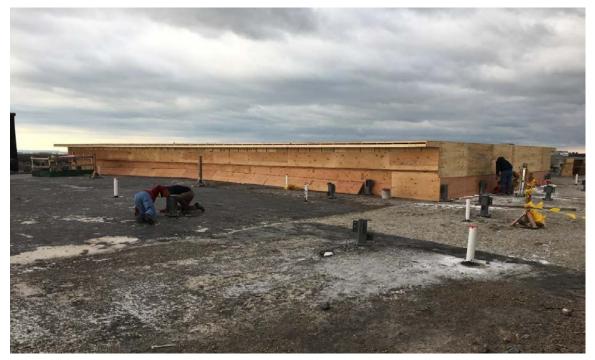
View of the roof cap.

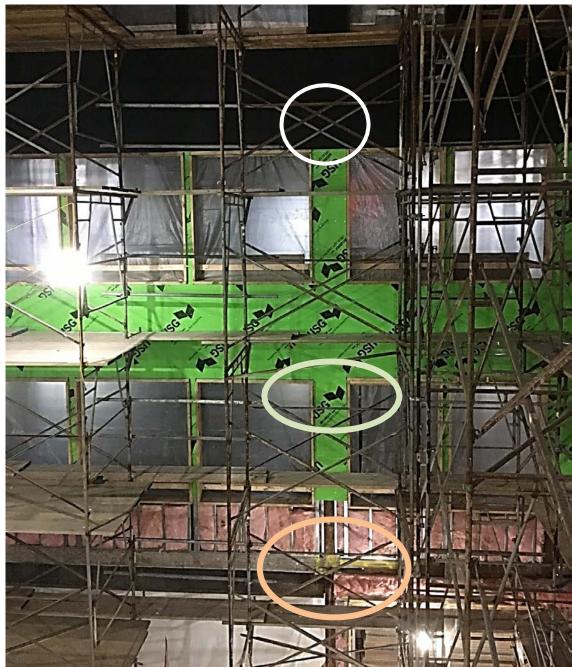
Pictured above is an example of the sequence utilized to create the façade;

- The pink circle shows the exterior side framing of the apartment wall with batt insulation
- The green circle shows the batt insulated exterior wall then sealed in a 2" rigid board insulation
- The white circle shows the fully insulated wall covered in a weather barrier (like roofing paper)

The final veneer will be a solid cement panel system of varying colors (like an EIFS) with aluminum windows and trim.

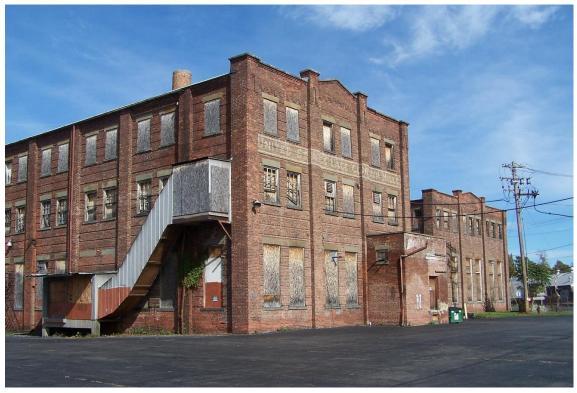
Façade of the south wing of the site, circa October 2013

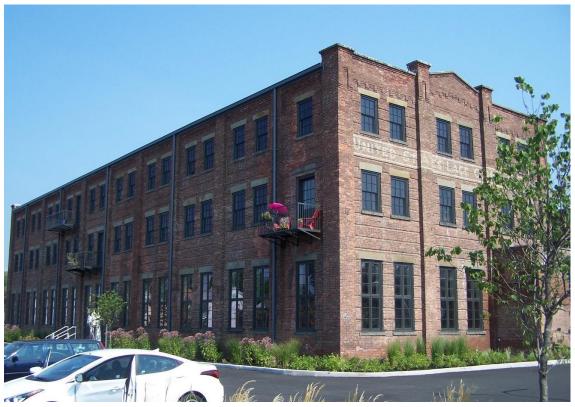
Façade of the completed south wing of the site, circa June 2015

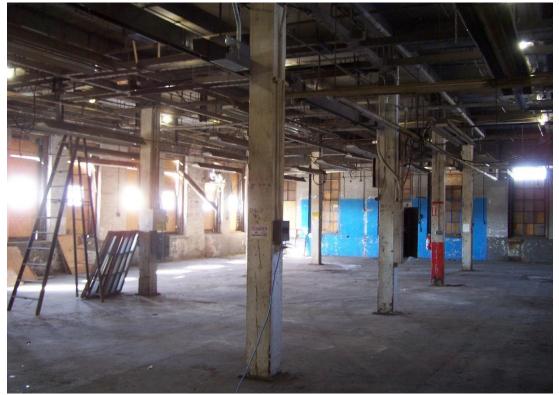
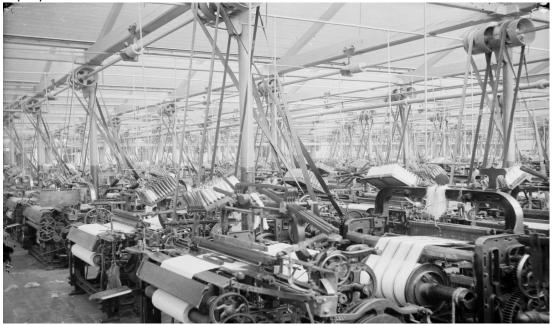
Note the tremendous height of this area. This part of the factory likely housed the heavy millinery machines which would have woven the raw threads and fabrics into linens. The original slabs were too deteriorated to preserve, and many sections needed to be opened to accommodate new infrastructure anyway.

The heavy slabs were needed to support the sheer bulk of the machines and the ceiling height was needed to accommodate both the size of the machines and the overhead pulley and belt system driven by the steam boilers. Pictured above is a typical knitting mill machinery floor circa the early 1900s, about the same time the Lace Factory was in business

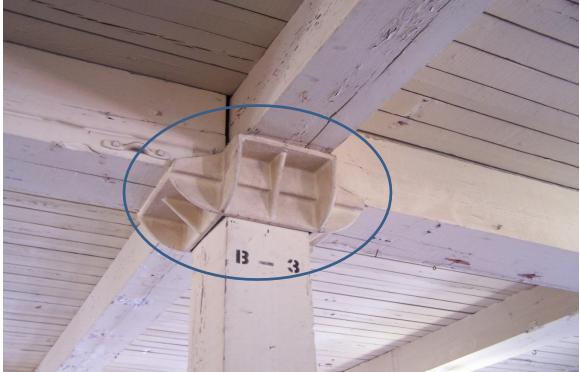
To attain National Parks Service (NPS) tax credits, as many of the original building elements were to be preserved as was feasibly possible. Exterior details are relatively easy to rehabilitate, but incorporating the huge structural elements of a post and beam foundry into residential units posed an architectural challenge. Circled is a typical support bridle.

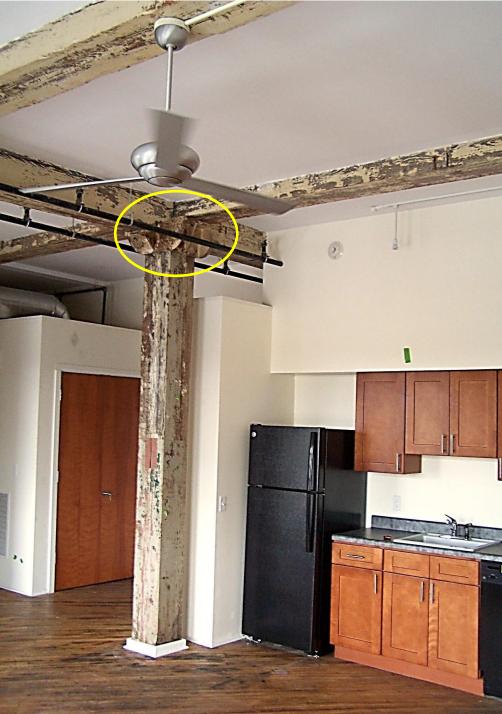
Support bridle incorporated into the final design. Note the "stressed" finish on the wood elements. Because they were all painted in lead based paint, they needed to be stripped per EPA mandates. In many cases, the stripping could not remove all the elements, and the posts could not be sanded down as they are all historic. Instead they were power washed to remove all loose material without damaging the wood, then encapsulated in a clear seal coat.

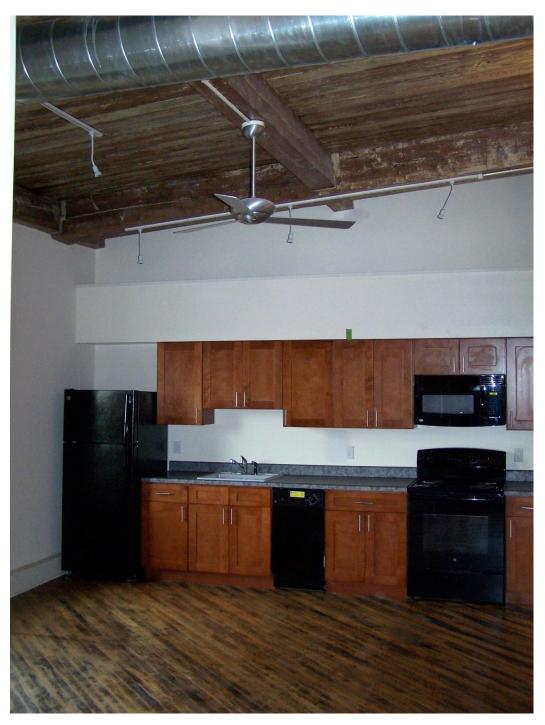
Completed unit kitchen at top floor of south wing-note the original beams and planking above. Most of the apartments incorporate some original element into their finish.

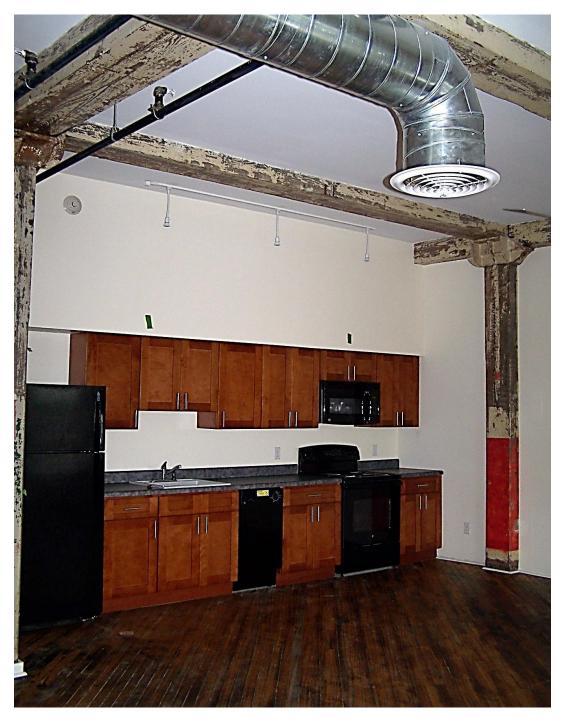
Because of the ceiling height, HVAC had to be hung throughout. The architects used an industrial design philosophy in selecting the type of ductwork used. That design sense was also used for other elements such as ceiling fans and lighting

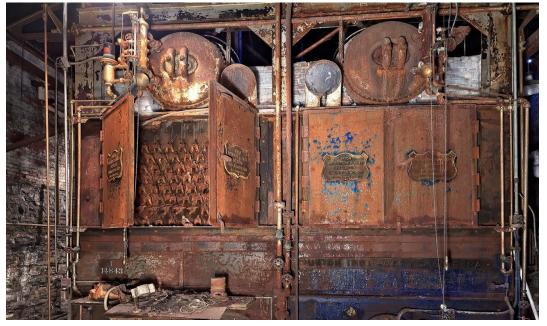
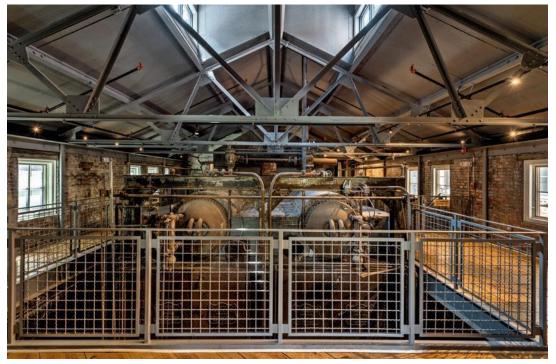
Pictured above are the original coal fired boilers which provided all the power for the Lace Factory when it was a knitting and fabrics mill. Manufactured by the Union Iron Works of Erie, PA, these boilers, circa 1903, are known as pressurized water tube units and are similar in design to those found on steamships of the era, including the Titanic.

At over 20 feet high, the cost to remove them would exceed any reasonable budget consideration, and as part of the overall rehabilitation of the site into affordable artist's housing, they will be preserved and cosmetically restored and viewable from an elevated platform above. The walls of the enclosure will act as display space for works by the red ident artists.

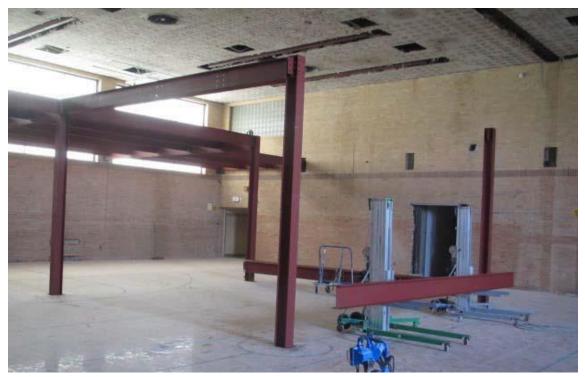
Construction of the steel framing for the platform

The former gymnasium was subdivided into three useable parcels: two sections of apartments and a new community room. This was done by first building a new platform to create two levels. Half of the lower level and all of the upper level became apartments, while the remaining half of the lower level became the new tenant community room

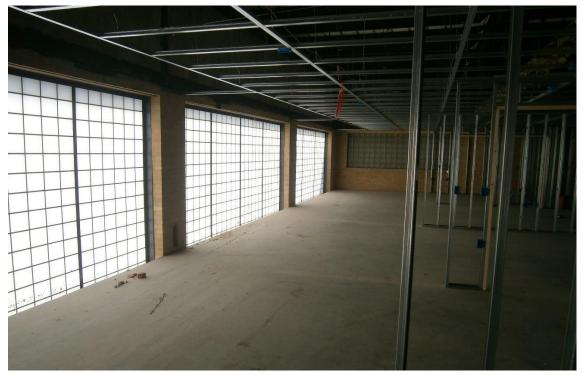
Poured slab for the new platform-the multi light windows would be replaced with residential grade windows which match the existing historic windows

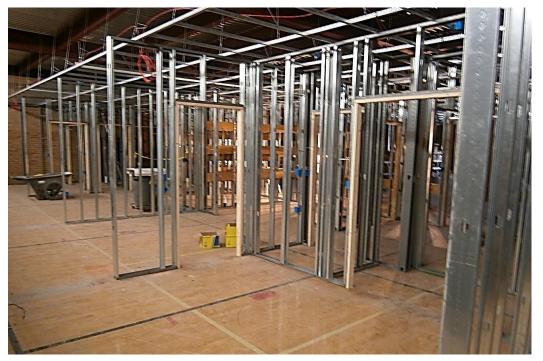
Apartment framing at the lower level in-progress. Much of original gym floor was preserved.

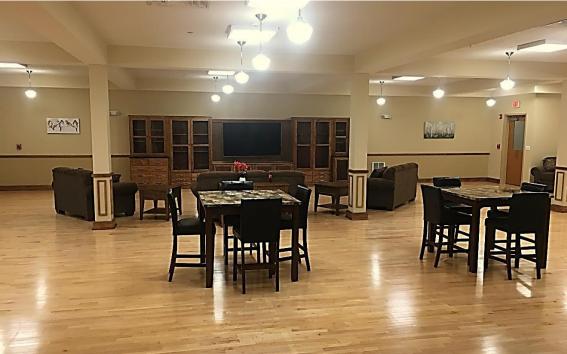
New Community Room built in the remaining gym space with original floor.

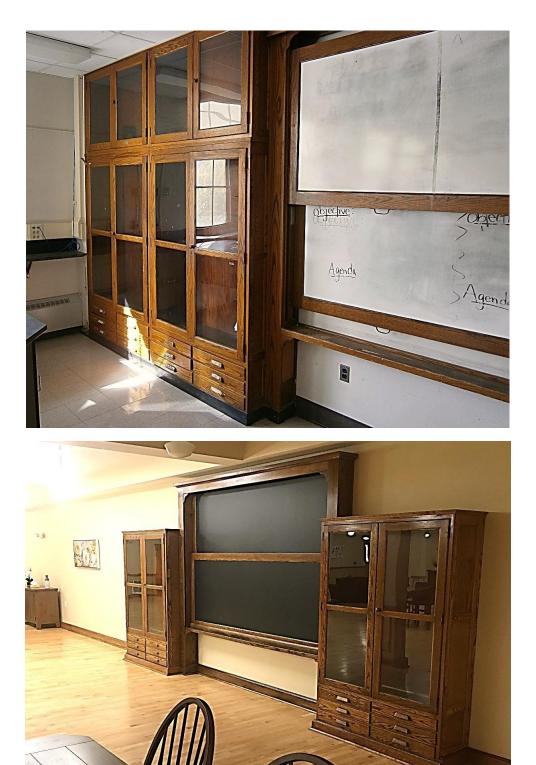
This original built-in wall case with two-tiered display board was reclaimed from a former science lab (above), and reconfigured for use in the new tenant community room

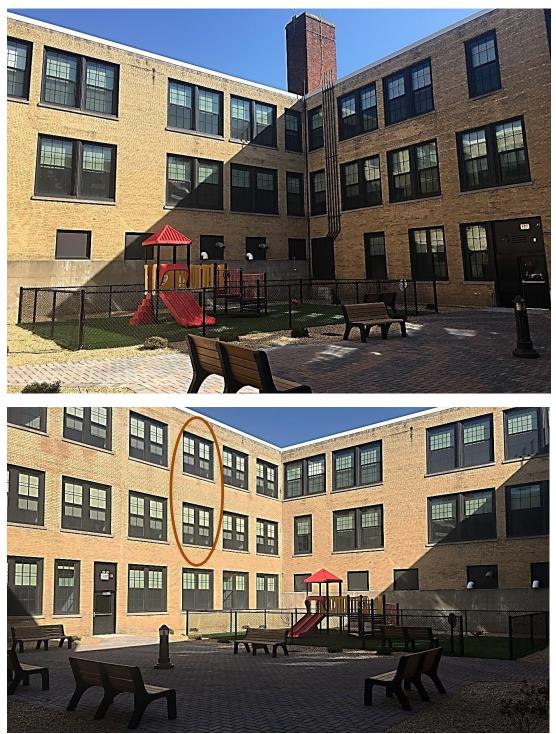
The original school courtyard was converted into a passive seating area and playground. The circled windows are the ones that serve the apartments built in the repurposed gym – replicas of the original windows on the adjacent wall.

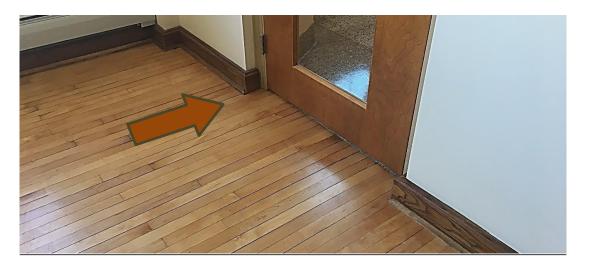
(Above) original slate window sills and polished veneer solid wood casings were all refurbished. (Below) Typical wood strip floors which were sanded and finished. New base moldings were fabricated from the solid wood eraser troughs from the original blackboard (most of the blackboards could not be preserved because they were adhered to their walls with an asbestos content mastic)

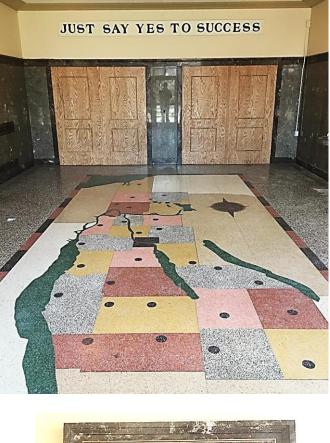
The original building entrance now solely serves the auditorium-the faux door panels closed off the school entry. The lobby itself features a mosaic relief of the Finger Lakes region which was cleaned and repaired as part of the rehab. Likewise, the original Federal Works Agency plaque, adorned with the name of <u>President D. Franklin Roosevelt</u>, was also restored

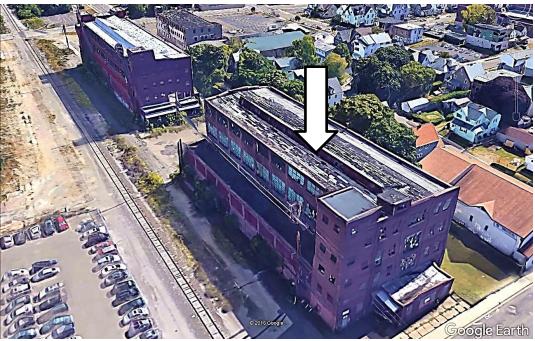
Aerial view of the site-note the arrow over the Century Building pointing out the building length skylights. During its time as a factory, these skylights served mainly as a ventilation point for the machinery housed on the upper floor.

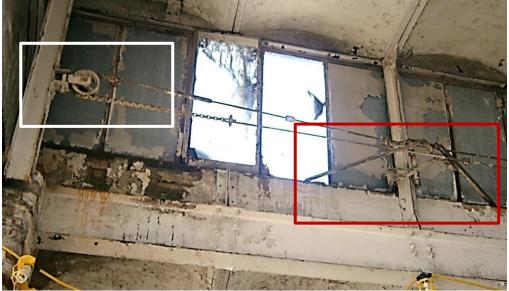
With historic preservation, any existing components which reflect the original purpose of the site are to be preserved. Pictured above is the mechanism which allowed the rooftop skylights to be opened and closed. The white box shows a pulley which could be controlled by a chain from below-as the chain was pulled, the wheel would in-turn pull a spring loaded cable which was connected to a set of scissor arms at the station of each window bay shown in the red box. The arms would push the non-fixed panels (which are the 3rd and 4th in this 5 panel bay) outward, allowing fresh air ventilation. These mechanisms are no longer operable but they will be preserved in-place, and new energy efficient fixed glass panels will be installed in all of the bays.

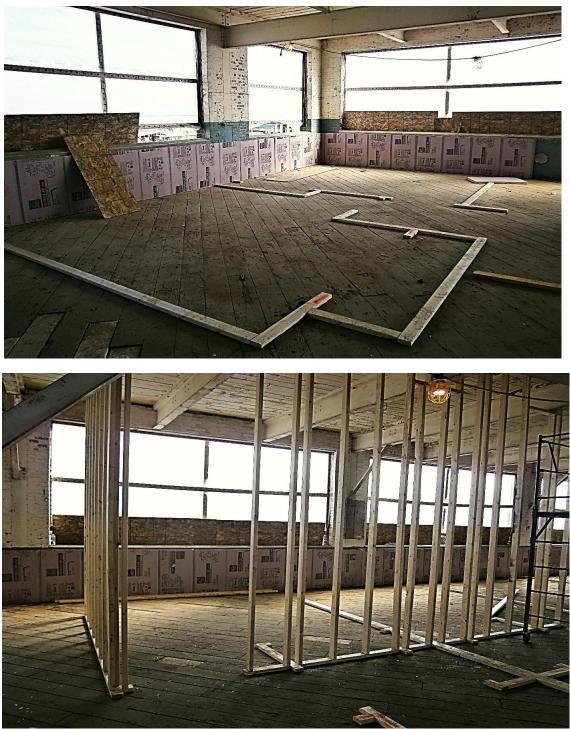
Initial apartment framing underway in the Century building. Because both buildings were constructed for industrial use, they are relatively intact and sound having been properly sealed over their years of vacancy. With the exception of some water damage at their roofs, and typical foundation settling, neither building is anticipated to need extensive structural rehabilitation. It is also planned to preserve the old growth lumber floors, and many of the posts and beams will be incorporated into the final apartment designs. The multi-lite windows will also be replicated.

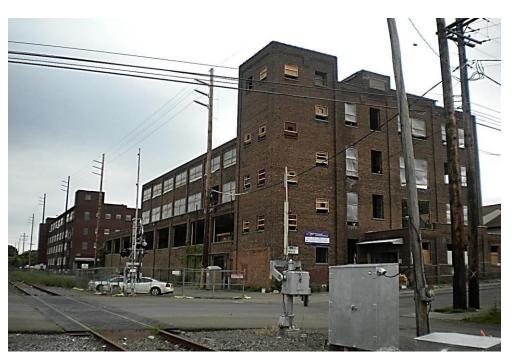
Site circa June 2017-window openings have been cleared and covered to protect the interiors from weathering during construction-they will all be laser measured to ensure the new windows fit perfectly.

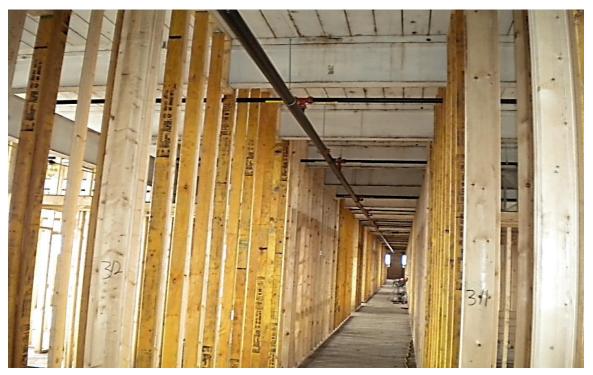
Hallway partition framing in progress at the Sunrise building – note the new sprinkler piping above.

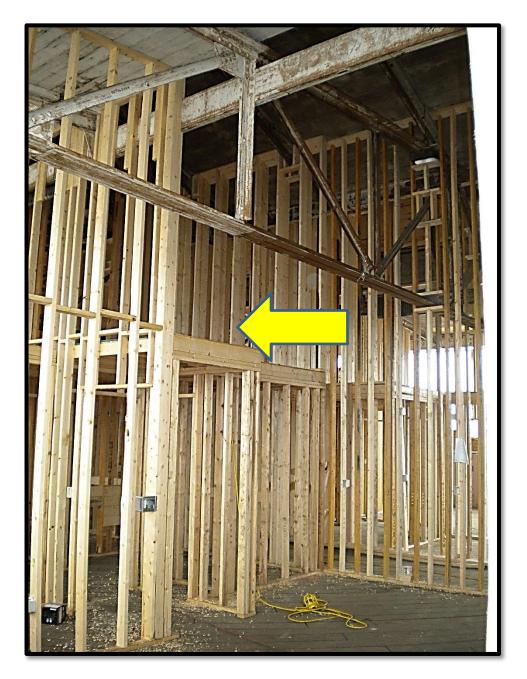
Pictured is a typical top floor apartment now in its rough framing at the Century Building. The new design will use the near 20-foot-high and existing exposed structure ceilings throughout. The above view is taken from the corner of the living room of a unit looking towards the doorway leading to a bedroom on the left and the bathroom to the right. The arrow points to a full height open space atop the bathroom which can be used for storage or, where large enough (they vary in size depending on the location of existing structural elements) a useable loft. For those apartments, an integrated ladder styled to reflect the era's architecture will be provided.

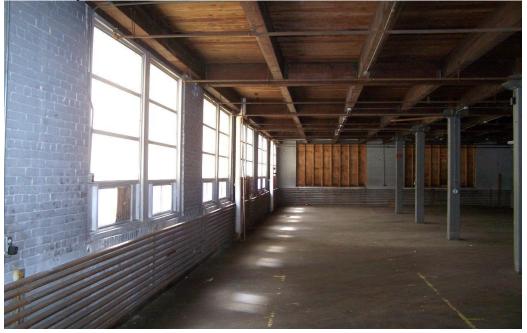
As seen in this picture from March 2014, the building is of heavy timber post and beam construction which was typical of structures designed to support massive industrial loads. This creates high ceilings and open floor spaces making the apartment layouts more challenging.

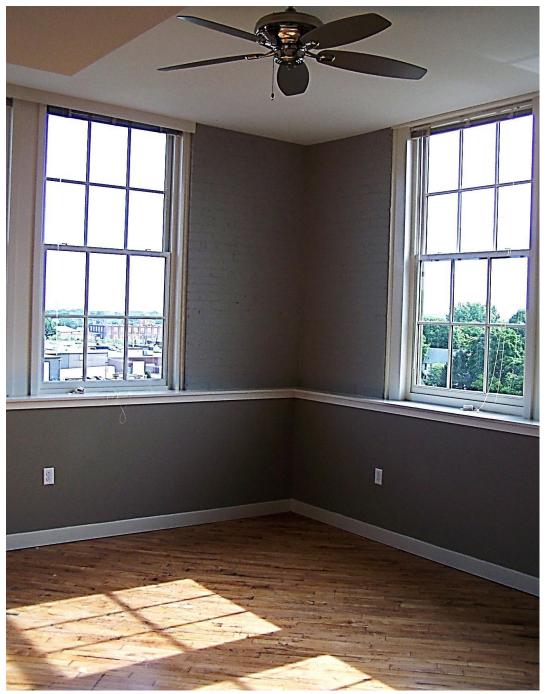
Typical living room at Michelsen. The architects used the open spaces to their advantage, designing large, open rooms benefiting from extensive natural light and ventilation. Note the windows which were all fabricated to replicate the type of windows prevalent in the 1920s, this done to garner historic tax credits from the National Parks Service (NPS). They also selected colors and accents in grey and green hues as reference to the building's former industrial use. Bedrooms and other living areas are likewise appointed.

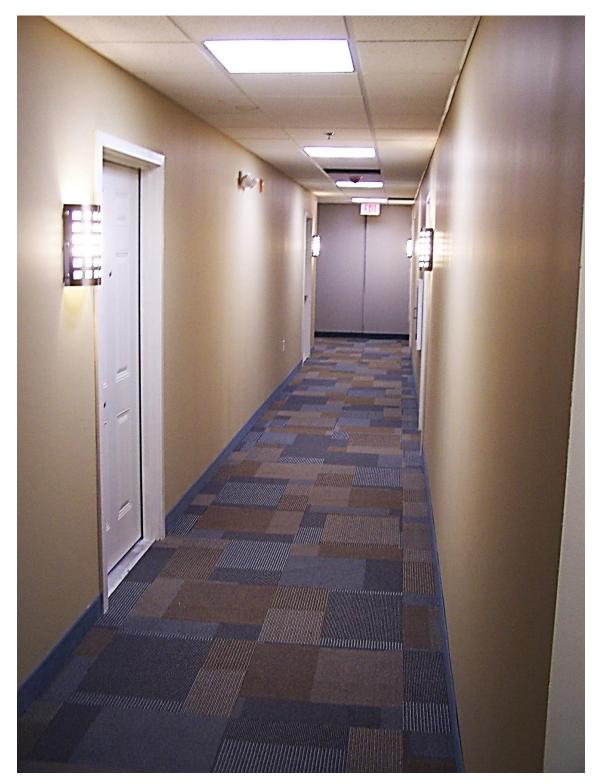
Typical public hallway at Michelsen. In order to address the potential noise issues of the former industrial high ceilings within these areas the architects designed drop ceilings with acoustical tiles and sound attenuating carpet squares whose color hues match the apartment interiors.

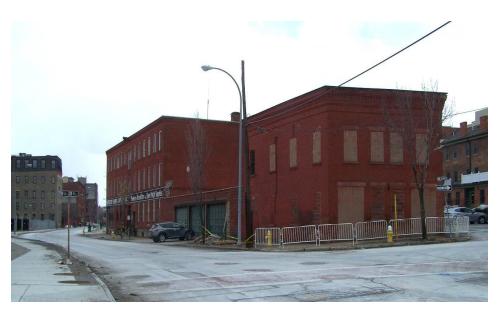
The Mills site consisted of three buildings-the building pictured above is the 2-sty structure on the corner of Mills Street and Brown Street which is likely older (circa 1850) than the three-story building (circa 1870) at the other end of the block on Mills and Factory Streets. The two buildings are separated by a later built three bay garage that was demolished to make way for on-site parking and open space. Many of the historic tax credits earmarked for this site focused on façade restoration, replication of windows and cornices, and preservation of hand-painted signage on the building walls.

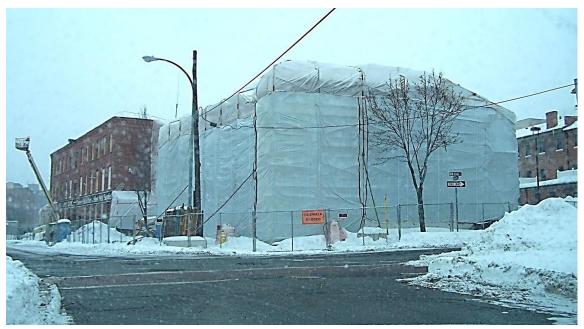
The structural restoration of the facades and foundations of the Brown Street building required protection over the harsh winter by a heated wrap. Masons worked unabated throughout to stabilize the building. As a result, the overall site progress was three months ahead of schedule.

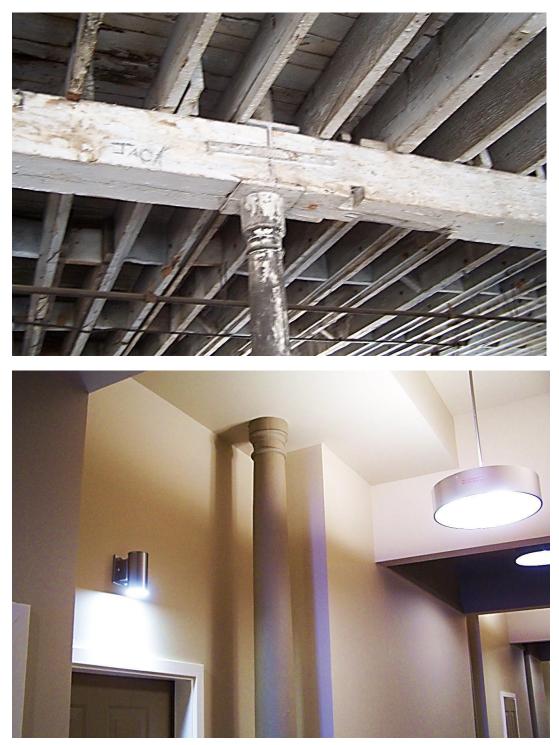
As with the Michelsen building, many original structural elements were incorporated into the final design. Note this rounded timber post in the Mill Street building which is still supporting its original loads but is now also a historic focal point in the public hallway at the ground floor

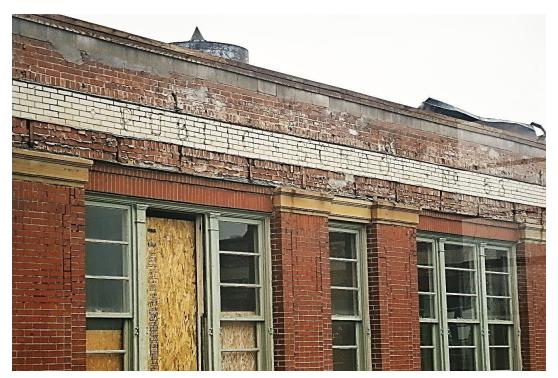
During the course of routine demolition, the cladding around the roof parapet was removed to assess the condition of the masonry-this revealed the long hidden brick inlay original school nameplate which will now be restored as part of the historic preservation.

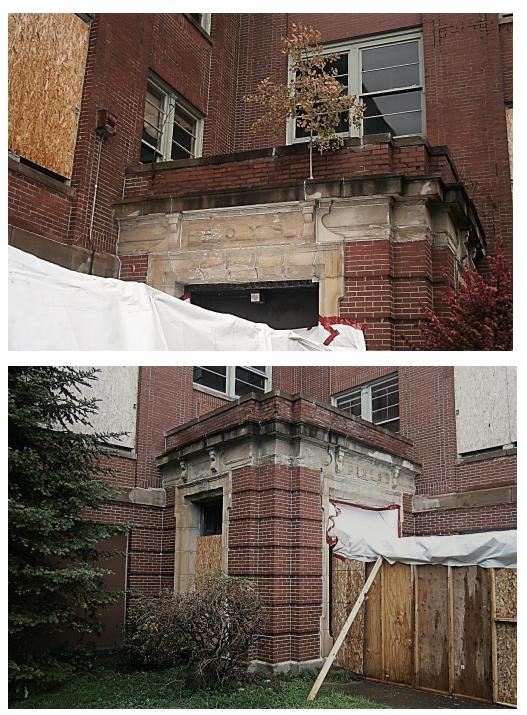
As with the parapet, the removal of protective cladding and barriers revealed more original architectural elements-these are the original entry porticos to the building. One each for Boys and Girls-they likewise will be restored.

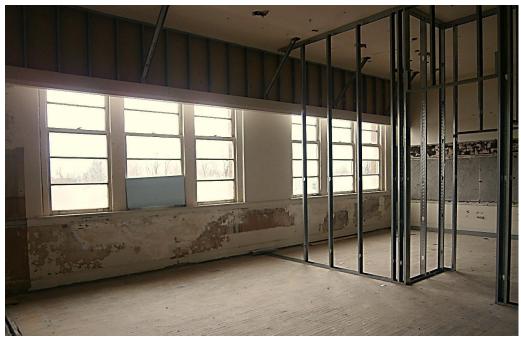
Typical classroom before asbestos and lead paint abatement above, gutted and rough framed classroom/apartment below. Note the original slate chalkboards – many were retained as a finish element in the apartments

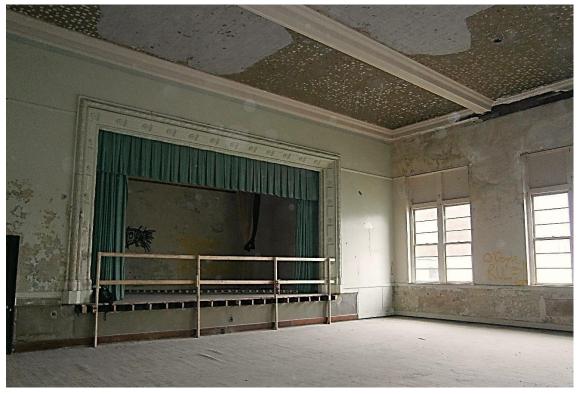
The stage from the auditorium with intact proscenium. New loft apartments were built into the double height space auditorium, taking advantage of the high ceilings by creating in-unit duplexes. The stage was preserved and left intact for tenant and community uses.

The refurbished auditorium stage (above). The room can be used by the tenants or the community for multiple purposes. The auditorium was reduced by about half its length and a new partition was installed. The height of the ceilings allowed for the construction of two duplex loft units. The approximate height of the platform within is noted by the dashed line above.

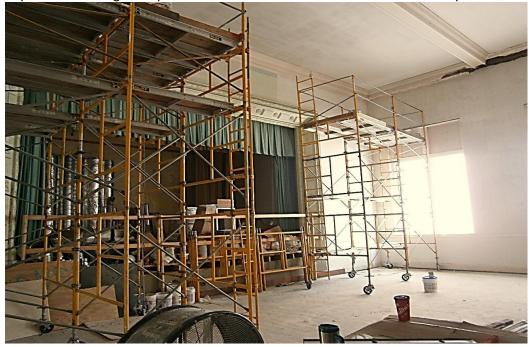
Restoration work in-progress, August 2017

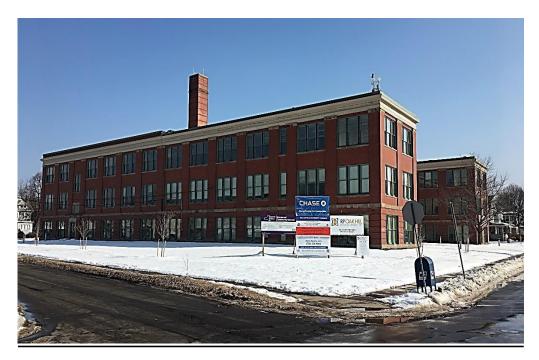
Completed façade included extensive masonry repairs, restoration of the original cornice and replication of the original "PUBLIC SCHOOL 63" signage. Final landscaping will be completed in the spring.

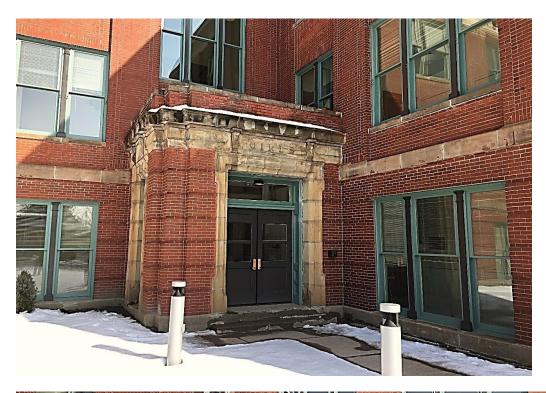
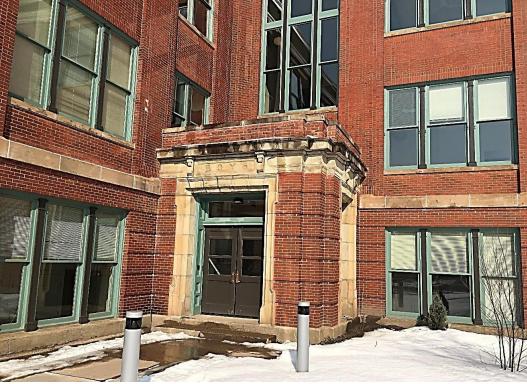
Restored Girls and Boys entrances. These are now mainly used for emergency egress

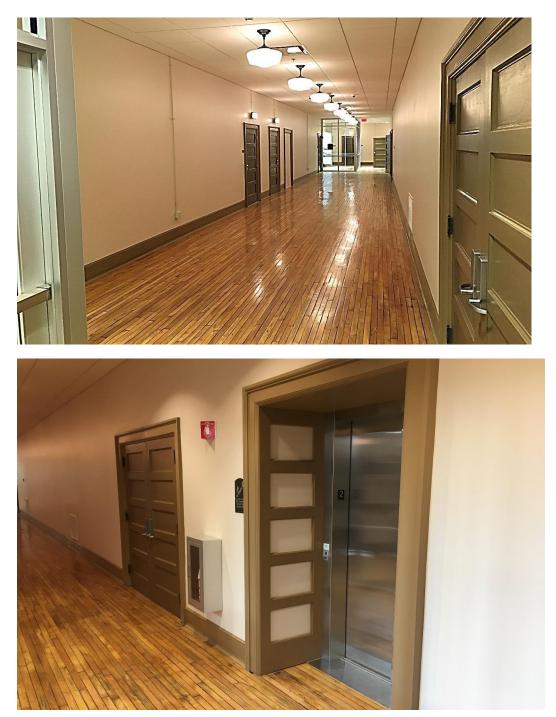
The majority of the original wood strip floors were salvaged, sanded and refinished. The architects also paid special attention to replicating color schemes from the buildings historical era. Likewise, other design elements reflect the buildings past; apartment entry doors are all five-panel style. Some of these unused doors were retained as a design element for entry porticos, such as for the new elevators. Overhead lighting throughout utilizes a globe design typical of public buildings.

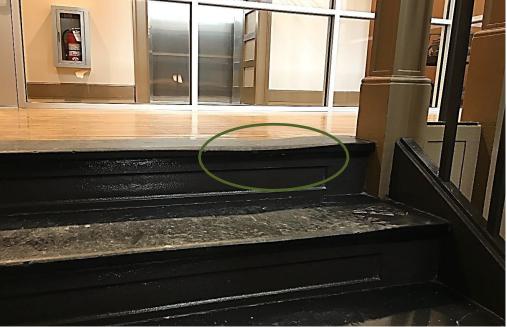
The site retains many historic elements, some grand, and some simple. The top tread on the up side of the original slate steps and at the first floor boards on many of the restored staircases shows an inundation worn into the slate and wood from years of students traversing these steps as they went to classes from floor to floor.

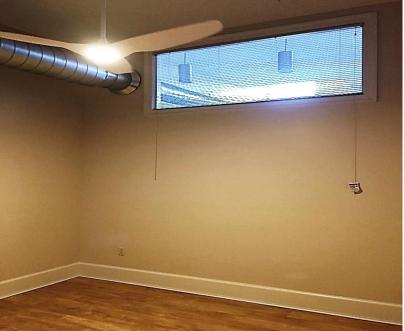
Several apartments were wide enough to allow for the inclusion of interior rooms which could be used as a secondary bedroom or habitable space. The height of the ceilings and windows provided ample light to use "borrowed light" designs.

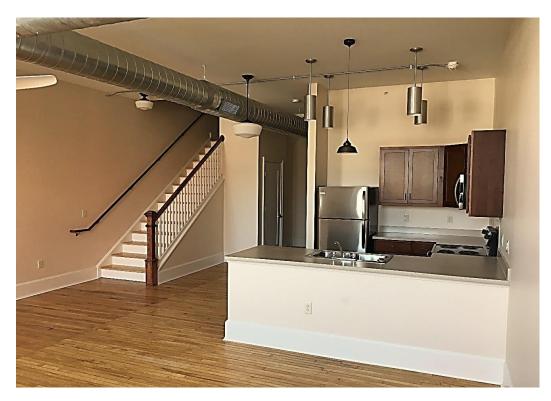
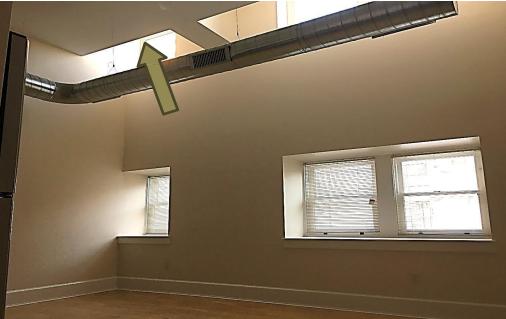
Interior views from the auditorium loft apartments – the platform ends short of the upper windows to allow for additional natural light into the floor below

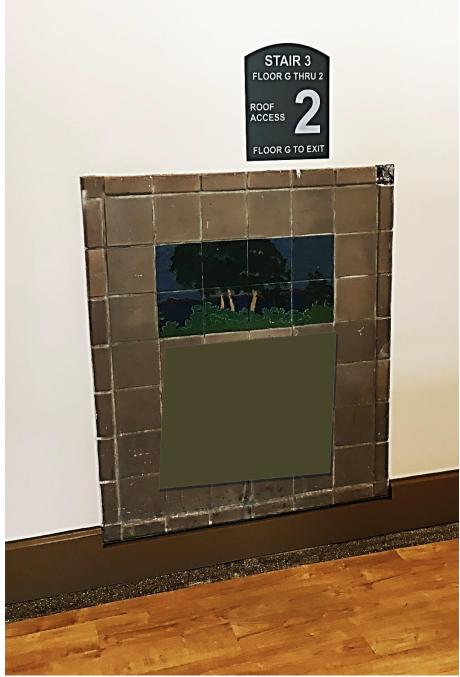
The original fountain relief – restored and preserved.
